AXIONE TAKES EMERGENCY ACTION ON A RADIO SITE AFTER A FIRE IN THE VAR REGION

RADIO SITES

BOUYGUES TÉLÉCOM

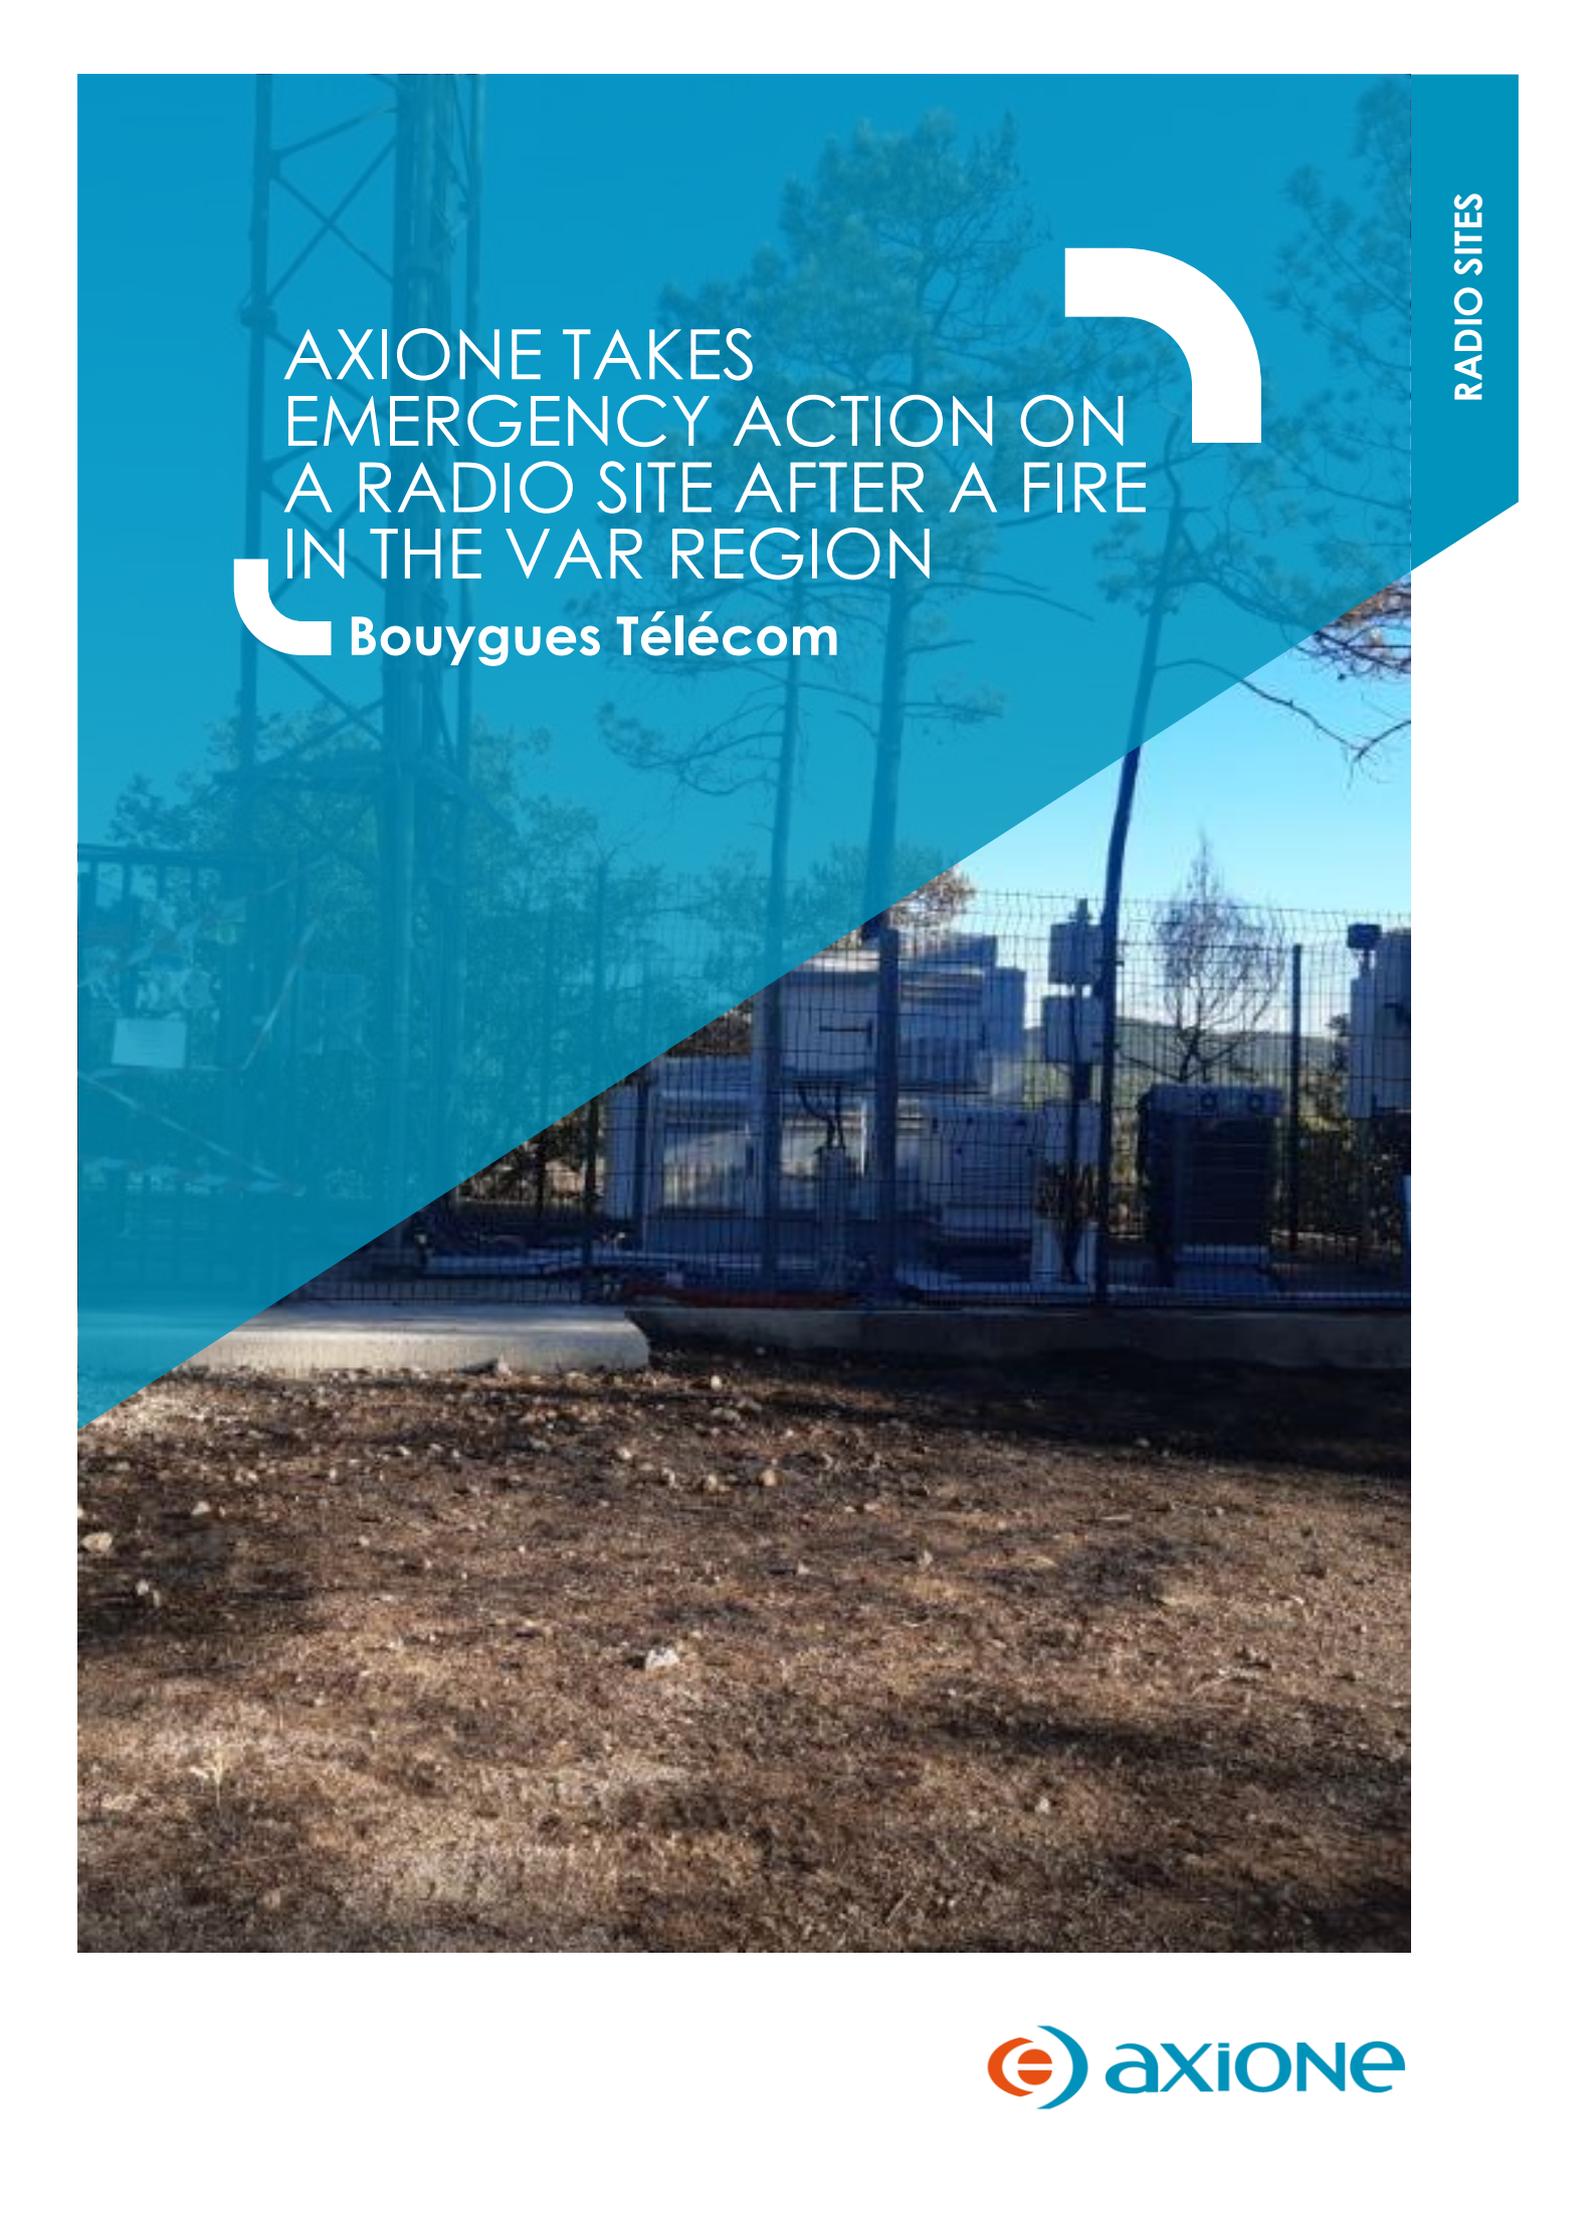
A photograph of a radio site in the Var region, France. The site is enclosed by a metal fence and contains several large metal cabinets. In the foreground, there is a large area of dry, brown grass and soil, indicating a fire. A tall metal tower is visible in the background. The image is overlaid with a blue gradient and white text.

Following a fire that ravaged 25 hectares of vegetation and damaged radio infrastructure in Mazaugues (Provence-Alpes-Côte d'Azur), Bouygues Télécom called on Axione's teams in Aix-en-Provence to restore the network.

The radio beam link could only be re-established after changing the entire feeder line and the transmission equipment: emergency replacement of the ODU (Outdoor unit) and the IDU (Indoor unit) by Bouygues Télécom. The replacement of the existing burnt radio cables required the intervention of two other technicians. The site was back up and running within a few days, providing 2G, 3G and 4G.

- Restoring the radio link
- Replacement of the entire feeder line
- Change of transmission equipment: ODU and IDU
